Balandžių g. Minijos g. Žuvėdrų tako g. paviršinių nuotekų kolektoriaus d1200 defektai nuo šulinio 151.105b10 iki šulinio 233.105a12

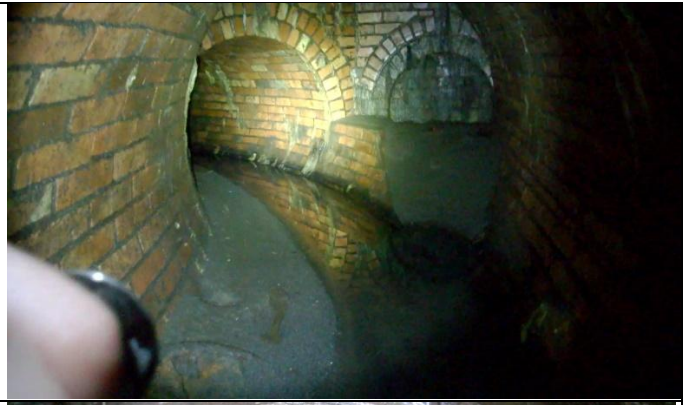
lasa gruntinis vanduo
