## Survey Report

Description: Filter Element, Air Conditioning No.7 Mk1 (Gas AEP-54)

PA Ltd Report No SRN 6798 refers.

## Portsmouth Aviation Ltd Survey Report Form

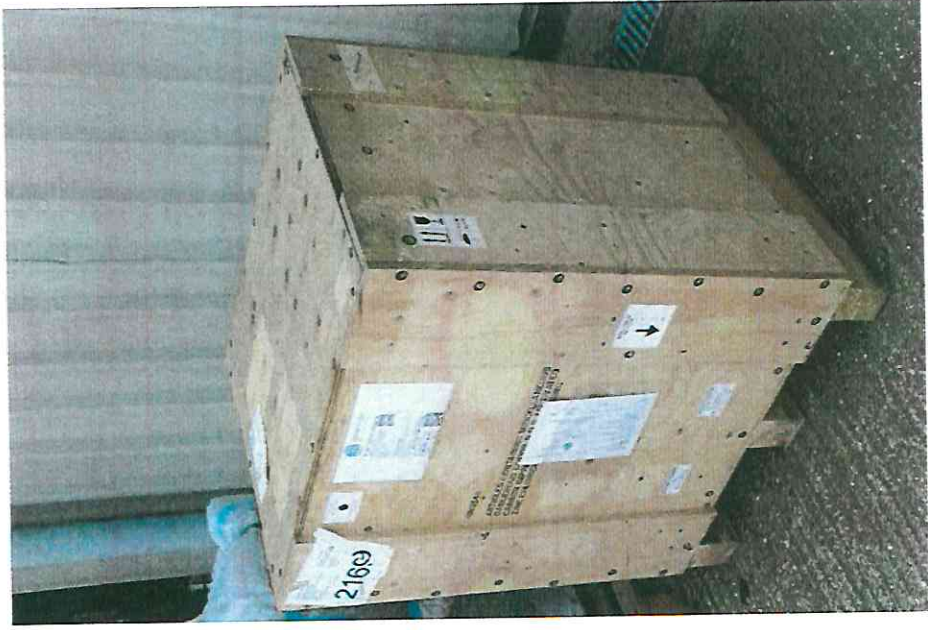
| a. Packaging before opened. | | | |

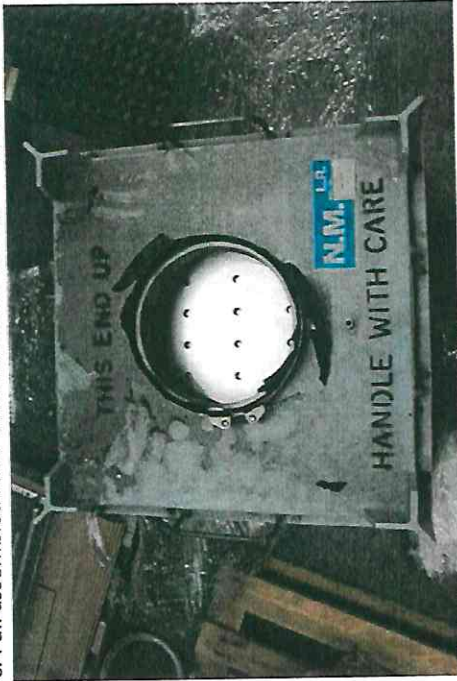
| <p>Supporting Information / Photos:</p> <p>c. Full assembled Filter after removed from packaging.</p> <div data-bbox="400 1335 858 2013"> </div> <p>d. Close up of Identification Plates on Filter.</p> <div data-bbox="611 369 1058 1037"> </div> | | | |

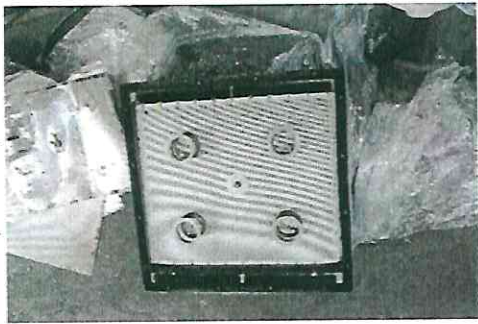
| <p>Supporting Information / Photos:</p> <p>h. 'D' castings once separated (view from above).</p> <p>i. 'E' casting and vent tube (view from below).</p> | | | |
